# BMW Headlight Fault Detection Case

**How to Use TOPDON RLink Lite and ISTA-D  
to Perform BMW 3 series Diagnostics**

**Vehicle Information:** BMW F30, manufactured in 2016, equipped with B48 engine and a driving mileage of 68823 km.

**Customer Feedback:** The vehicle's headlights reported malfunction. Both headlights cannot light up. The vehicle has been flooded before.

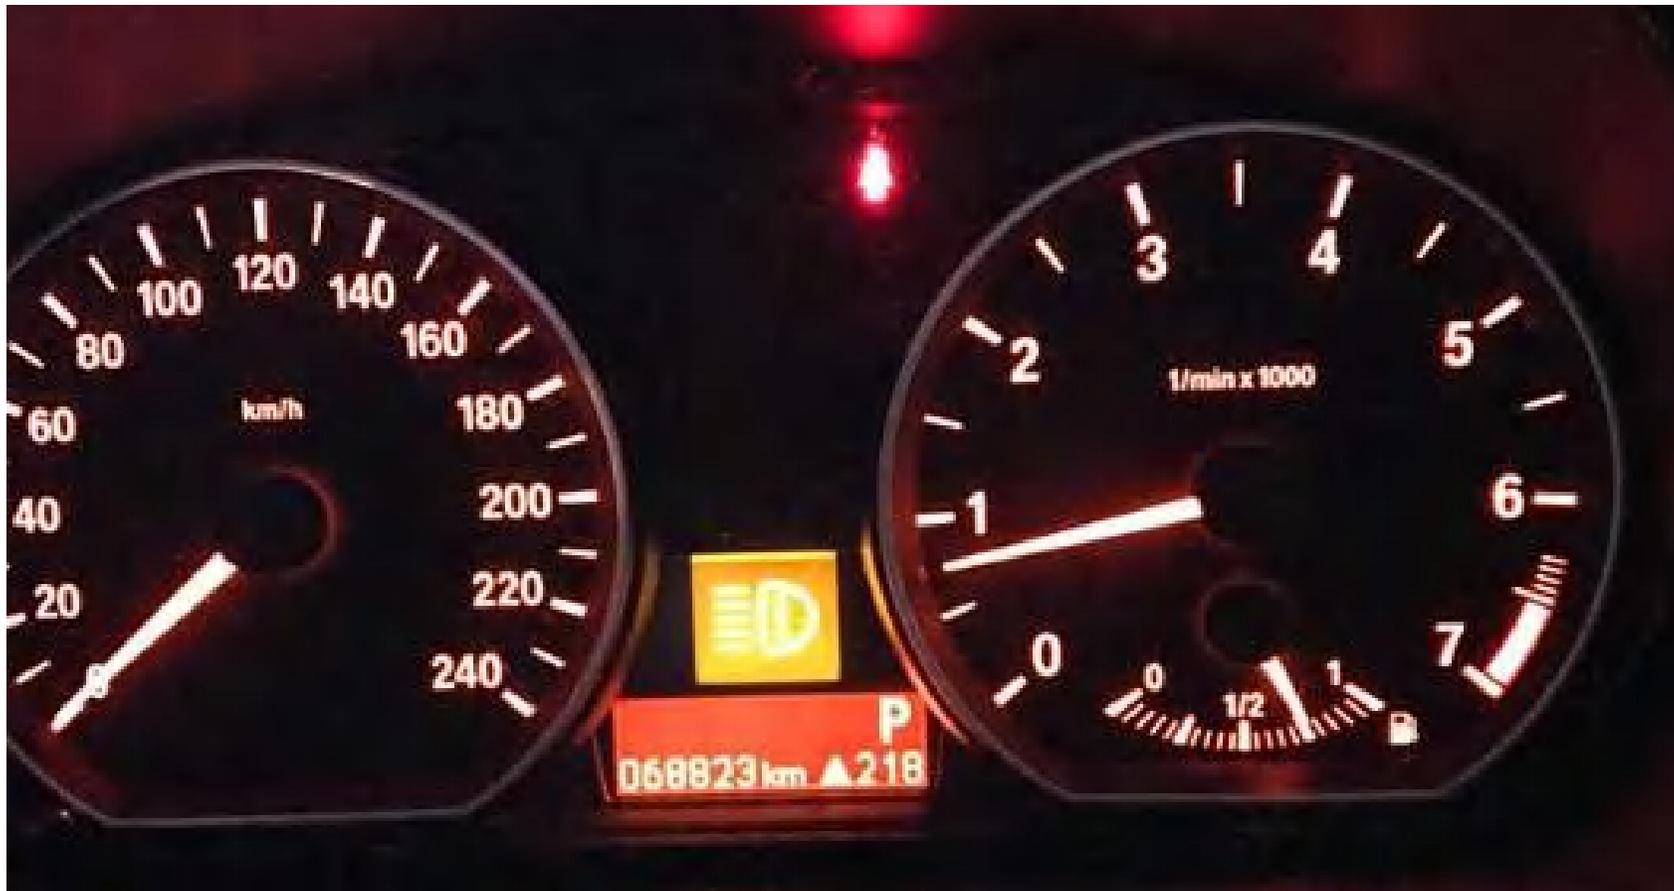
1. Start the vehicle and check that both headlights cannot light up.
2. The instrument shows headlights failure.
3. The headlights failure will seriously affect driving safety. Let's see how to check this fault.

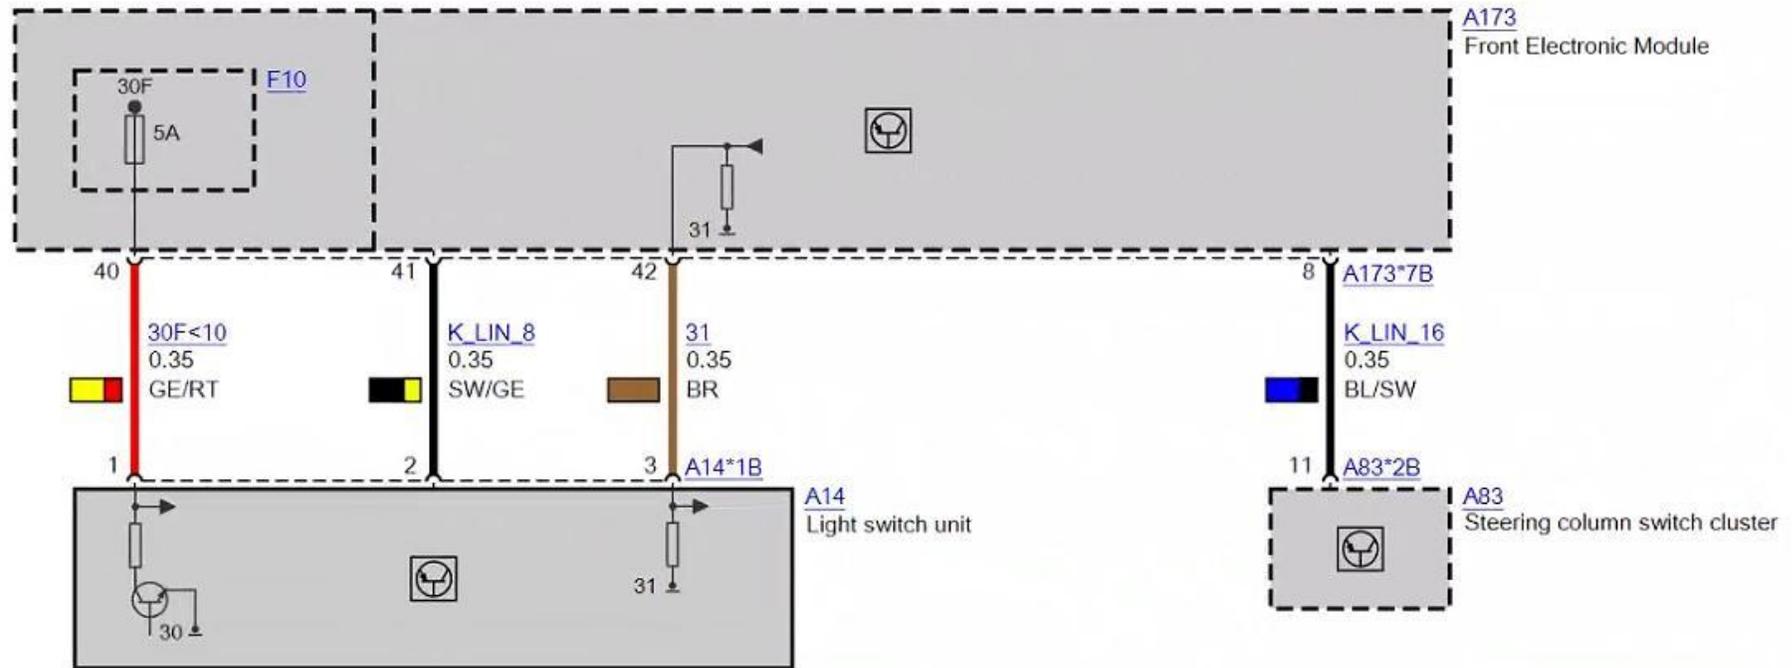
3. Headlight switch test: Check that the headlight switch fuse, the bond strap of power supply, and the test switch signal are normal. (As shown in the figure above, F10 indicates fuse, red wire indicates positive, gray wire indicates negative, black wire indicates signal wire.)

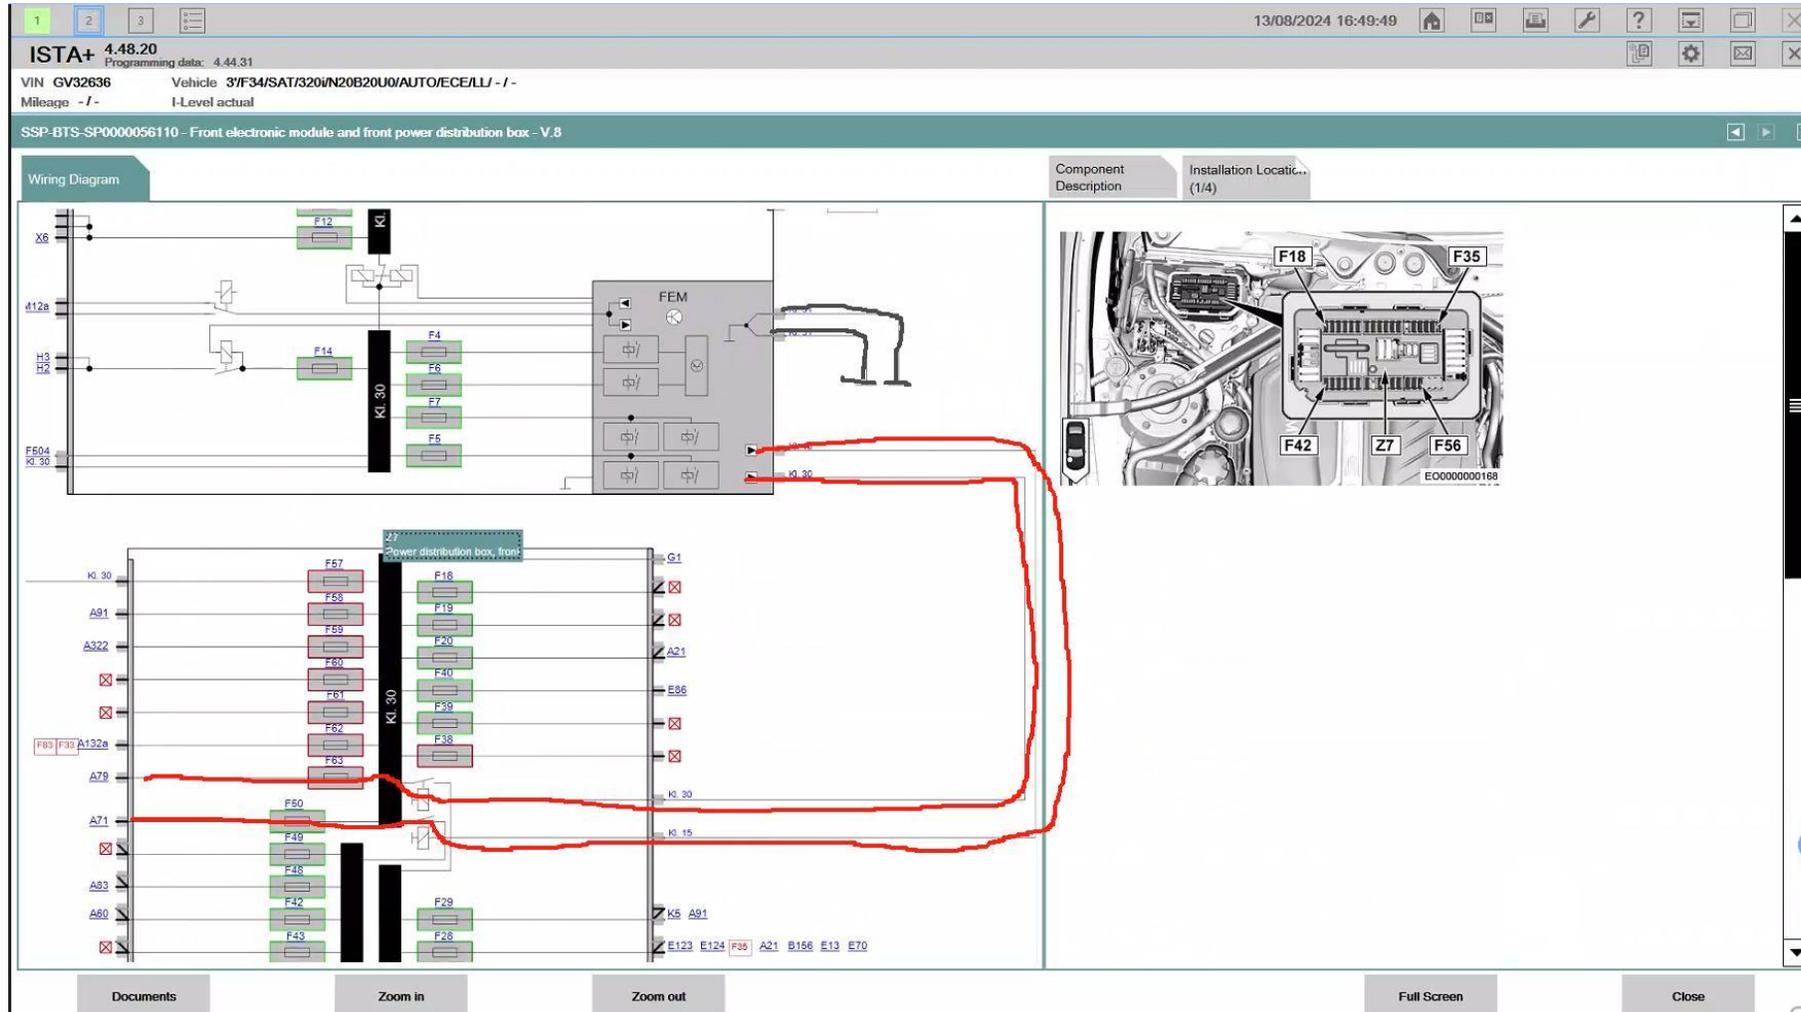
4. Check that the fuse, power supply, and the bond strap of the FEM module are normal. (Red wire indicates FEM power supply wire, black wire indicates bond strap, F50 and F63 indicates fuses, and the upper right is fuse box.)

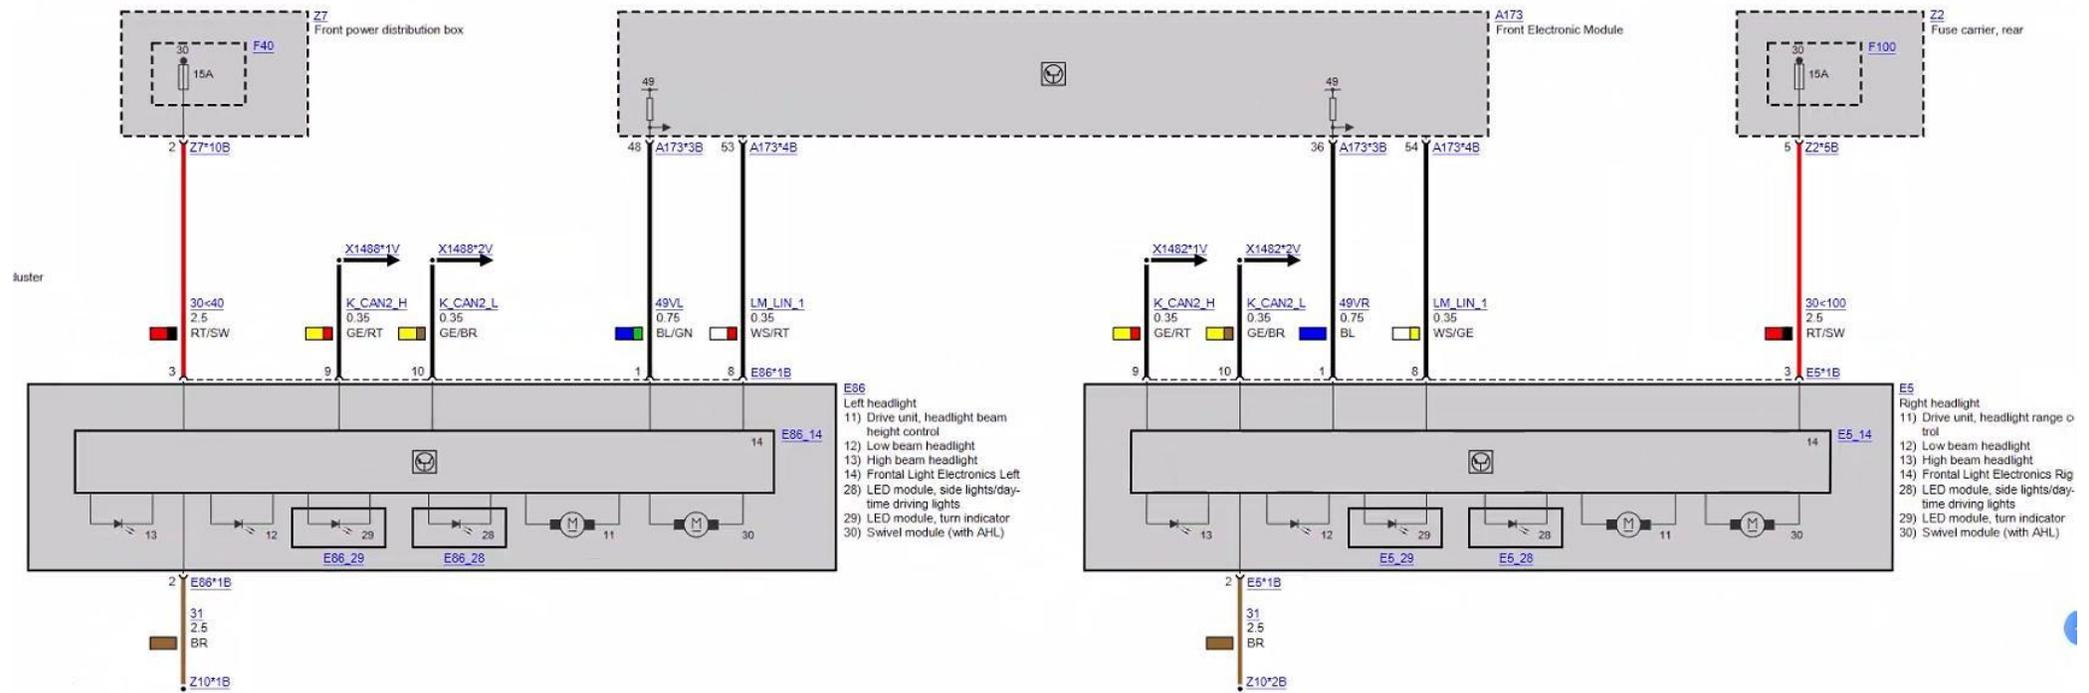
5. Check that the power supply and fuse of the headlights are normal. Turn on the headlights for testing. The signal from FEM to the headlight is abnormal and no voltage passes. (As shown in the figure above, the two red wires are the positive poles of the left and right headlights, the two gray wires are the negative poles of the left and right headlights, and the others are signal wires.)
6. Check the power status of the FEM to the left headlight signal wire. Pin 1 and Pin 48, Pin 8 and Pin 53 are normal. Check the power status of the FEM and the right headlight signal wire. Pin 1 and Pin 36, Pin 8 and Pin 54 are normal. Suspect that the FEM is faulty.

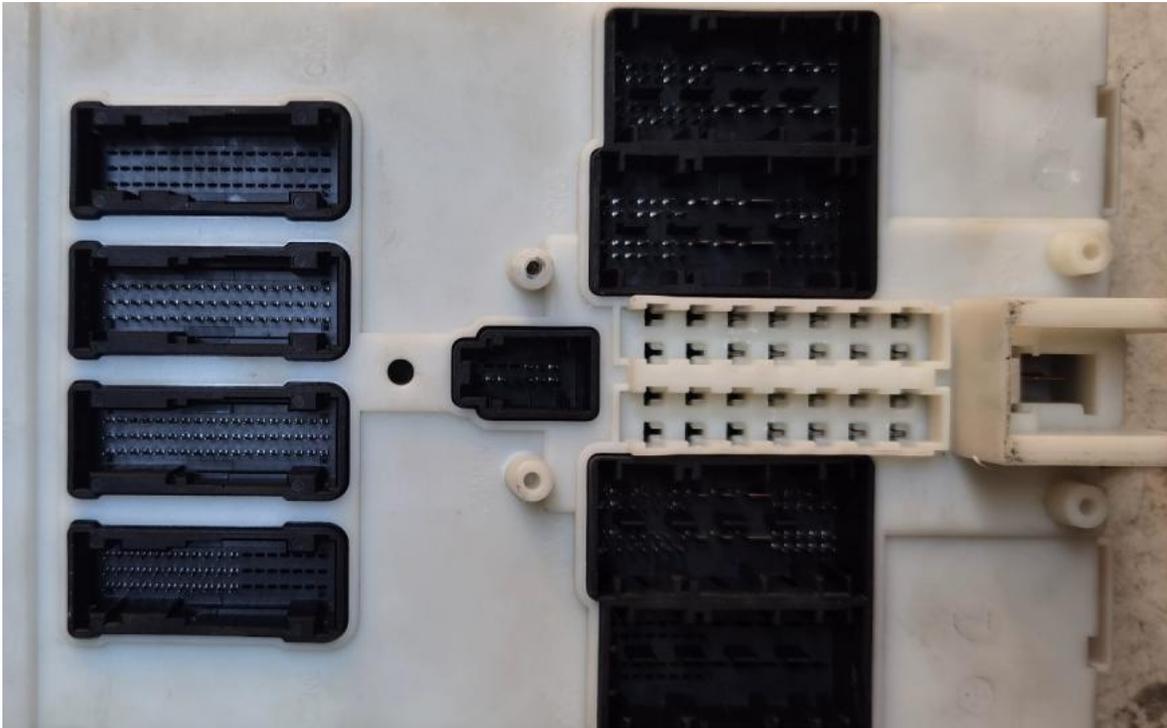
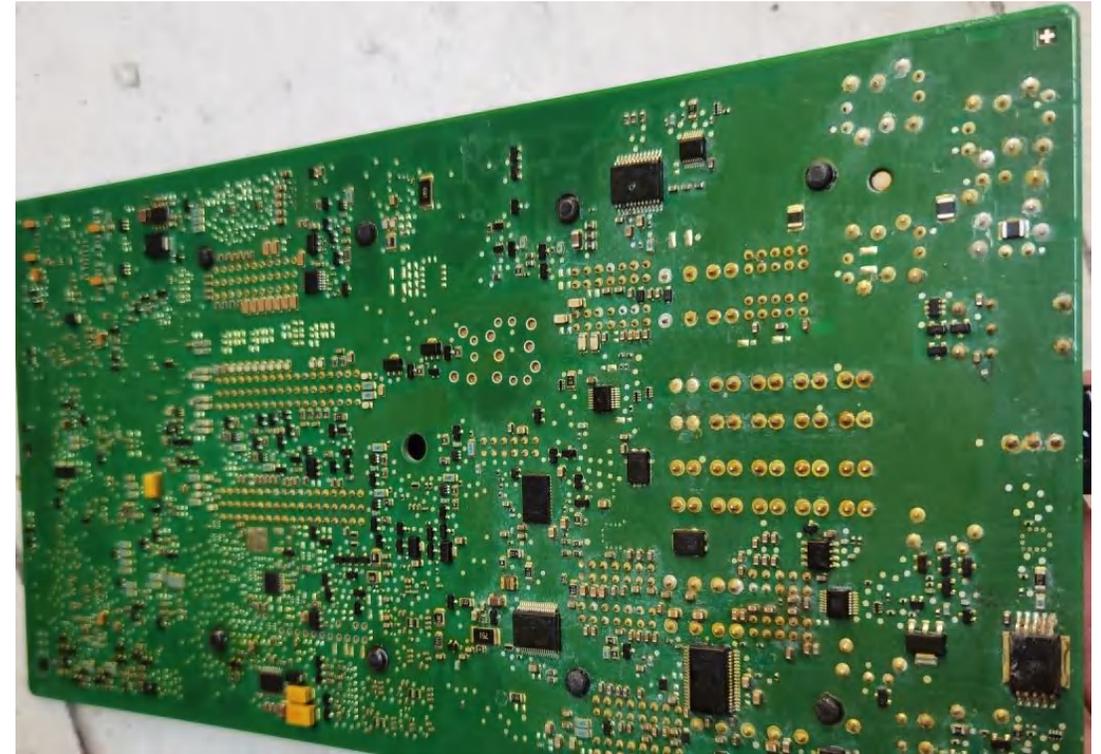
7. Remove the FEM and find traces of water immersion. Disassemble the FEM and find serious corrosion inside the FEM. Confirm that the FEM is damaged.
8. Replace the FEM and the fault is solved.

Tips: Replacing the FEM requires programming. If you use engineer programming, you need to copy the old FEM data first and then write to the new FEM.
